# Fire Risk Assessment of External Cladding Systems on High Rise Residential Building (Phase 3 Report)

101 – 508 Caspian Apartments  
5 Salton Square  
London  
E14 7GJ

Report date: 27/03/2020

Building reference: 158598

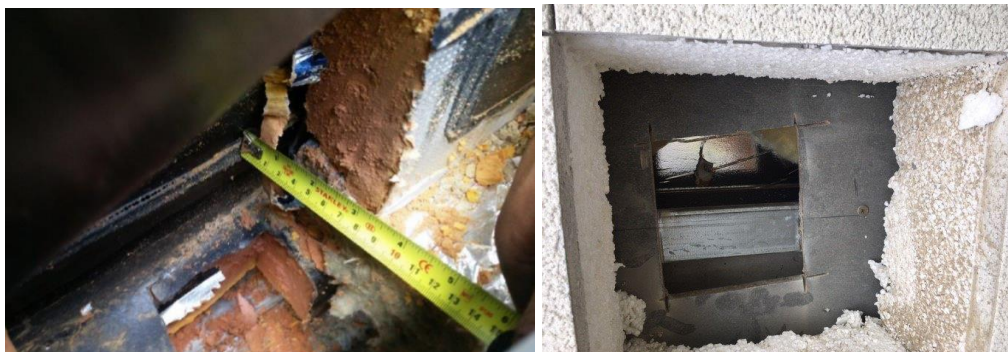
Two types of insulation are known to be provided. The areas behind the metal cladding are provided with a rigid phenolic foam board insulation. There is an air gap behind the foam board to which an intumescent strip has been provided to close the gap in case of fire.

The insulated render areas are provided with expanded polystyrene insulation (EPS) behind the outer render coat. Behind the EPS is cementitious board fixed to a metal frame with mineral wool insulation between the board and concrete floor slab.

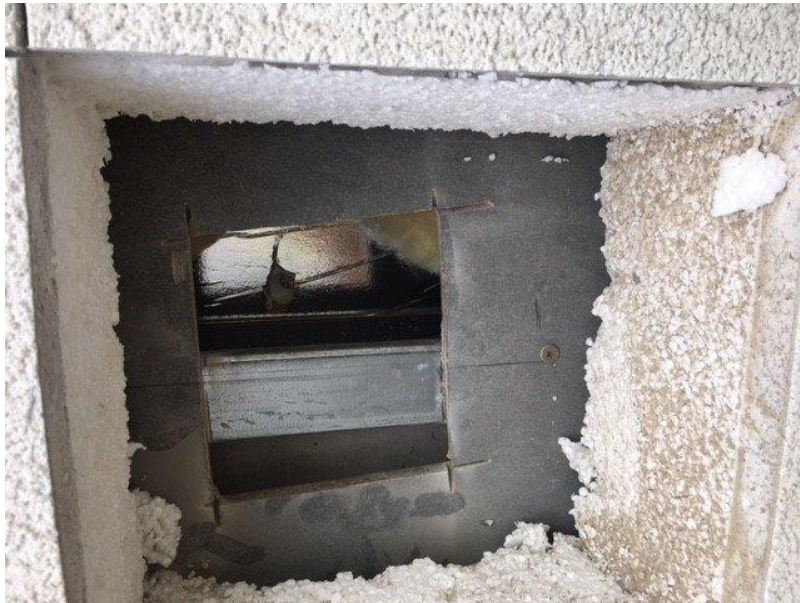
The insulated render system, which comprises a layer of cement render over expanded polystyrene, has no cavity barriers evident at floor slab level. Mineral wool is provided behind the cementitious board. This is not in accordance with the manufacturer's design or with Approved Document B.

This means that a fire involving the insulation can pass unchecked between compartment floors, affecting adjoining compartments and potentially leading to delamination of the render and full involvement of the insulation in fire.

Without the design drawings, it is not possible to state whether the lack of cavity barriers within the insulation is a design or an installation deficiency. These systems are required by the manufacturer

's design details to have cavity barriers that extend out to the inside of the render at each compartment floor level.

Cavity barriers are required to be provided at each floor level and compartment wall, to continue out to the inside of the render coat in the insulated render system. This could be achieved by opening up the render at each floor level and inserting a full width cavity barrier before making good the render.
