TECHNICAL GUIDANCE NOTE

Fire Risk Assessment of External Cladding Systems on High Rise Residential Building (Phase 3 Report)

Coral Apartments
6 Salton Square
London E14 7GL

Building reference: 160130 – G01-612 – Coral Apartments

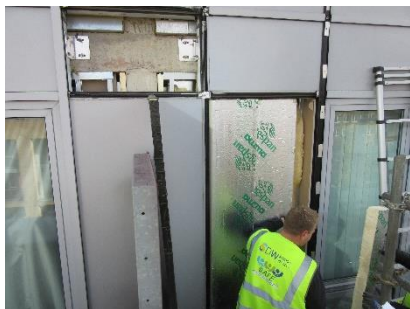
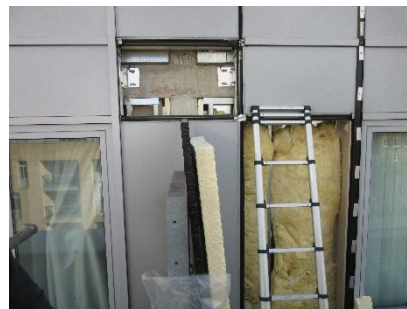
The insulation behind the metal panels is a polyisocyanurate (PIR) foam board (Kingspan Kooltherm) with mineral or glass wool quilt behind.

The PIR foam insulation provided behind the metal cladding would have met the requirements of the Building Regulations at the time of construction, and there are BR 135 approved systems where PIR insulation is acceptable in conjunction with aluminium cassette panels and plasterboard on a steel frame.

It is not considered necessary to replace the metal cladding and insulation since there are tested BR 135 build-ups for these materials. Although the mineral wool layer is not present in the tested detail, since this is non-combustible, as is the wall board behind it, it is unlikely to affect the performance of the system.

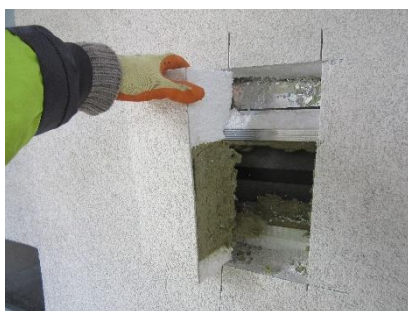
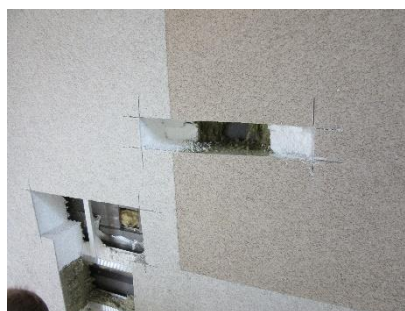
The insulation behind the rendered areas is expanded polystyrene.

At the rear of the premises, the majority of the external envelope is a rendered EPS which, although cavity barriers are present at horizontal and vertical compartment lines, is not a limited-combustibility material and does not comply with guidance. It may have been considered to comply with the Building Regulations at the time it was registered, depending on whether this was pre-2010. However, the building is believed to be eight years old; if this building was registered post-2010 then the use of EPS over 18m does not comply with ADB or MHCLG guidance.

Replace combustible EPS (expanded polystyrene) with material meeting the Euroclass A2 requirements, or upgrade system to one which is BS 8414 tested & BR 135 approved.

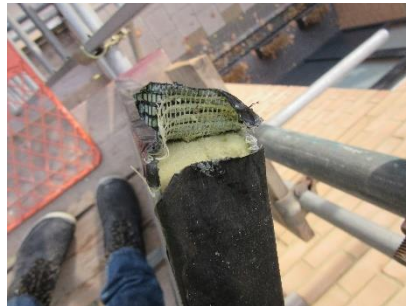
The spandrel panels contain a man-made foam core, thought to be polyisocyanurate (PIR) foam.

The use of PIR foam in the spandrel panels is also non-compliant. These would meet the Class 0 requirement under the 2010 guidance but not the limited combustibility requirement for a building over 18m.

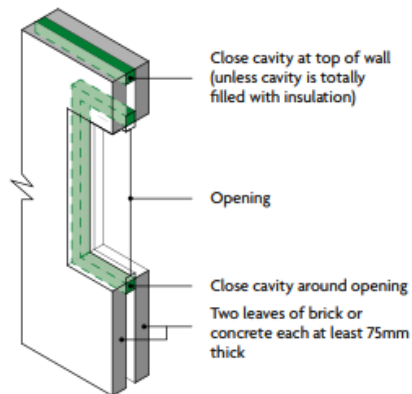
Cavity barriers were found at horizontal levels and at vertical compartment walls in the insulated render system cavity. Cavity barriers were not seen around openings as required (see diagram above), although this is unlikely to have been a specific requirement of the manufacturer's guidance at the time of construction.

Provide cavity barriers to all windows.

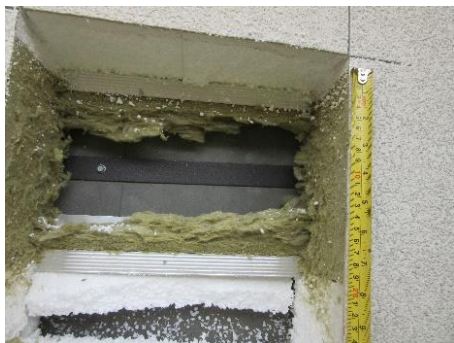
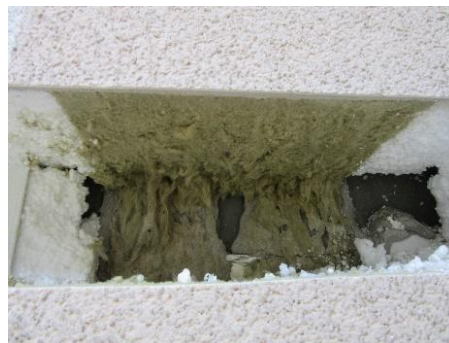
However, the barriers are not full thickness since the polystyrene is 120mm deep and the cavity barrier 100mm, leaving a 20mm gap to the rear of the barrier through which hot gasses and flame could pass to the next compartment.

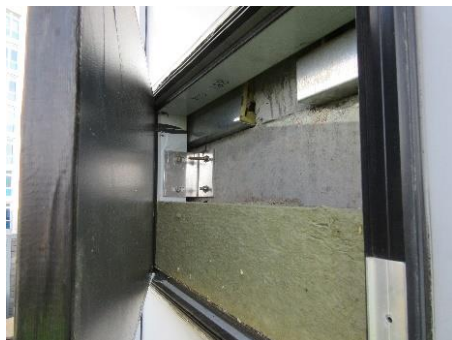
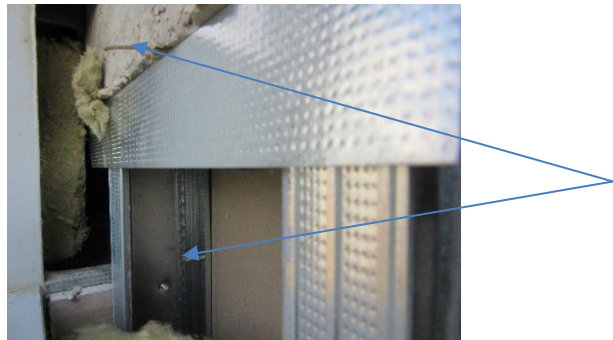
Cavity barriers were also found behind the coated metal panels where insulation is fitted. These barriers are required on a horizontal plane between floors, on vertical planes separating different flats, and around windows.

The vertical barrier was removed in the lower part of the righthand picture above to reveal the board behind.

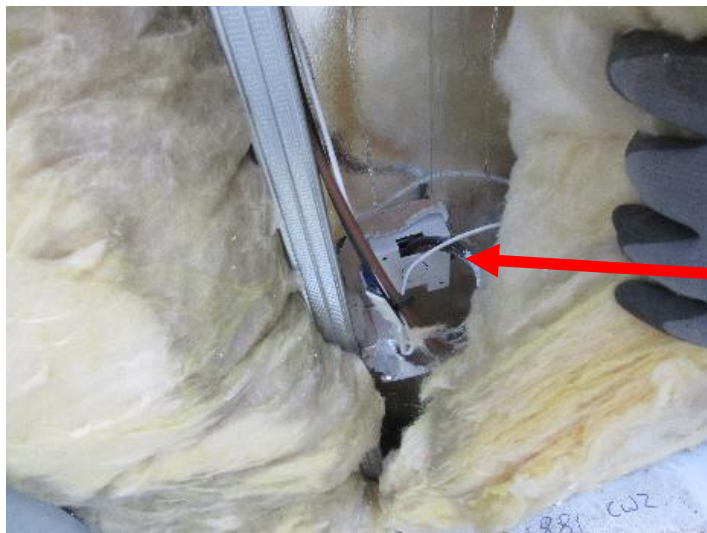
It was also noted during the intrusive survey that the wallboard forming the inner skin of the external envelope had been cut away to fit plastic socket boxes (TV aerial box shown in the picture below). These do not appear to have been fire stopped with either putty pads or fire-resisting back boxes. This could allow a fire within a flat to pass through the fire-resisting construction and involve the flammable insulation.

Provide putty pads or fire-resisting back boxes to plastic socket boxes and tv aerial boxes that penetrate the wallboard in the external envelope.
