Fire Risk Assessment of External Cladding Systems on High Rise Residential Building (Phase 3 Report)

Flats 101 – 1303 Iona Tower

33 Ross Way

Report date: 30/03/2020

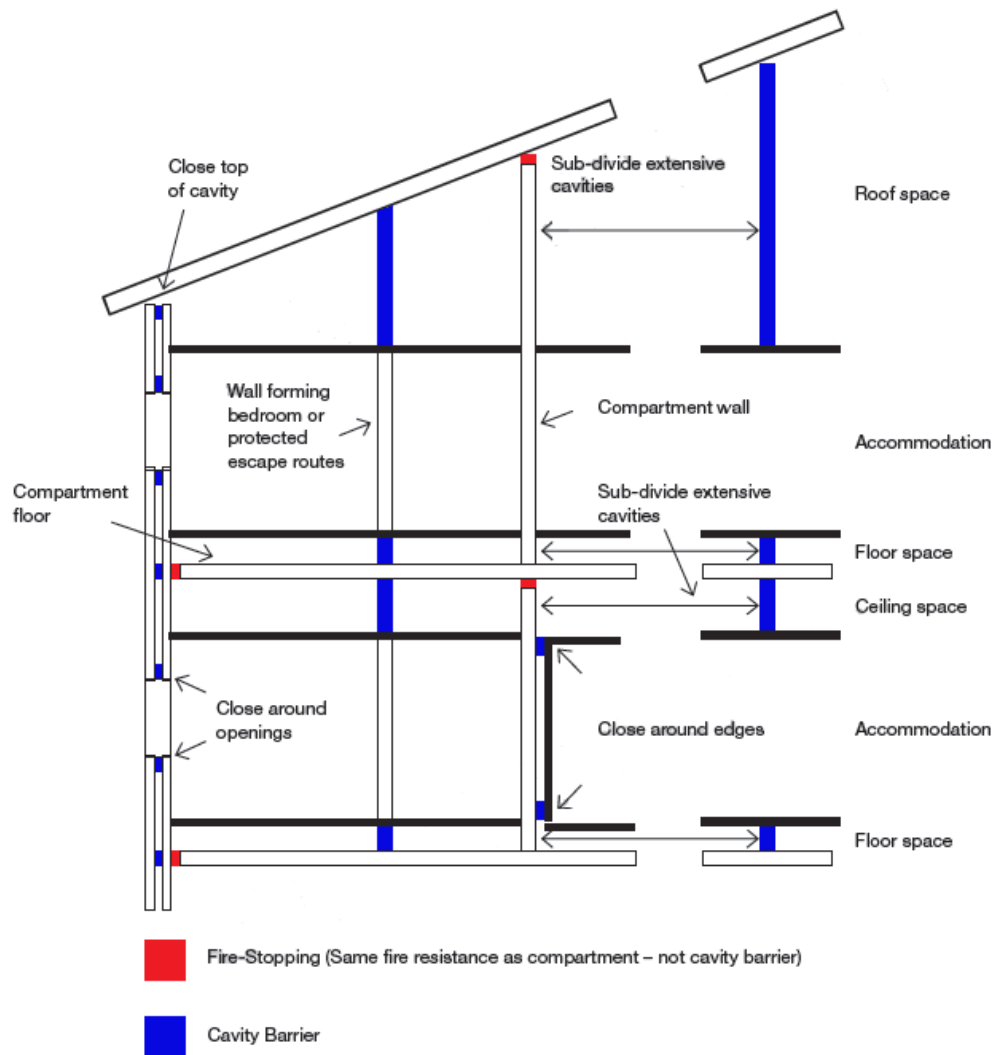
Figure 4.1 Provisions for Cavity Barriers

Cavity barriers should be provided in accordance with Diagram 33 overleaf.

A fire barrier was observed between flats where opening up works were carried out, however, the barrier did not extend out through the phenolic foam insulation as provided in the tested detail, nor did it appear to have a cavity closer (e.g. intumescent strip) to close the gap behind the insulation as in the design detail. This requires further opening up to confirm whether a barrier has been provided separating the insulation and providing a means to close the cavity at compartment floor level, and vertically between flats on any of the floors in this building. If a number of sample locations show the same deficiency, all cavity barrier locations will need to be opened up.

The design detail includes a 20mm cavity with an intumescent strip on the profile to close the cavity behind the cavity barrier. These were not found in all locations where the opening up works were undertaken.

Medium term measures: Provide appropriate cavity barriers to all locations where compartment walls and floors are present and around openings such as windows and doors.
