Fire Risk Assessment of External Cladding Systems on High Rise Residential Building (Phase 3 Report)

Malin Apartments

38 Ross Way

Report date: 5th March 2020

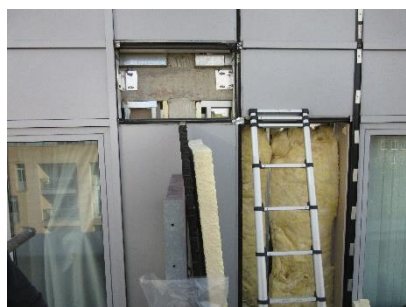
The insulation behind the metal panels is a polyisocyanurate (PIR) foam board (Kingspan Kooltherm) with mineral or glass wool quilt behind.

The PIR foam insulation provided behind the metal cladding would have met the requirements of the Building Regulations at the time of construction, and there are BR 135 approved systems where PIR insulation is acceptable in conjunction with aluminium cassette panels and plasterboard on a steel frame.

It is not considered necessary to replace the metal cladding and insulation since there are tested BR 135 build-ups for these materials. Although the mineral wool layer is not present in the tested detail, since this is non-combustible as is the wall board behind it, it is unlikely to affect the performance of the system.

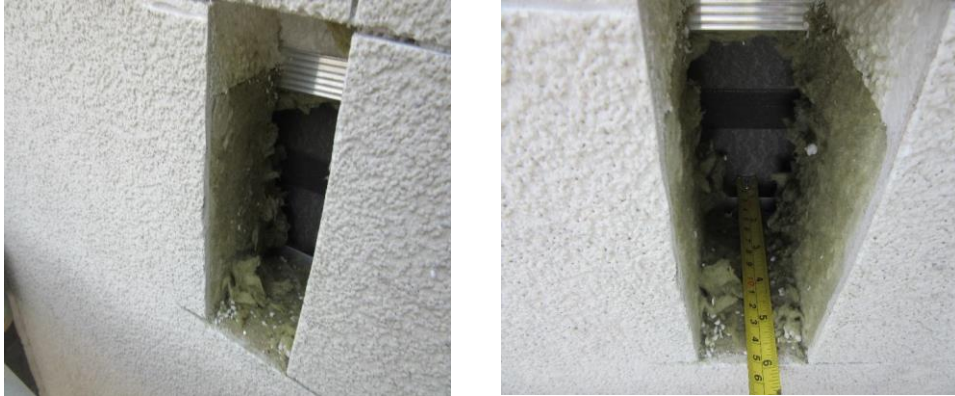
The insulation behind the rendered areas is expanded polystyrene.

At the rear of the premises, the majority of the external envelope is a rendered EPS which, although cavity barriers are present at horizontal and vertical compartment lines, is not a limited combustibility material and does not comply with guidance, therefore.

It may have been considered to comply with the Building Regulations at the time it was registered, depending on whether this was pre-2010. The building is believed to be eight years old. If this building was registered post-2010 then the use of EPS over 18m does not comply with ADB, or MHCLG guidance.

Replace combustible EPS (expanded polystyrene) with material meeting the Euroclass A2 requirements, or upgrade system to one which is BS 8414 tested & BR 135 approved (e.g. StoVario).

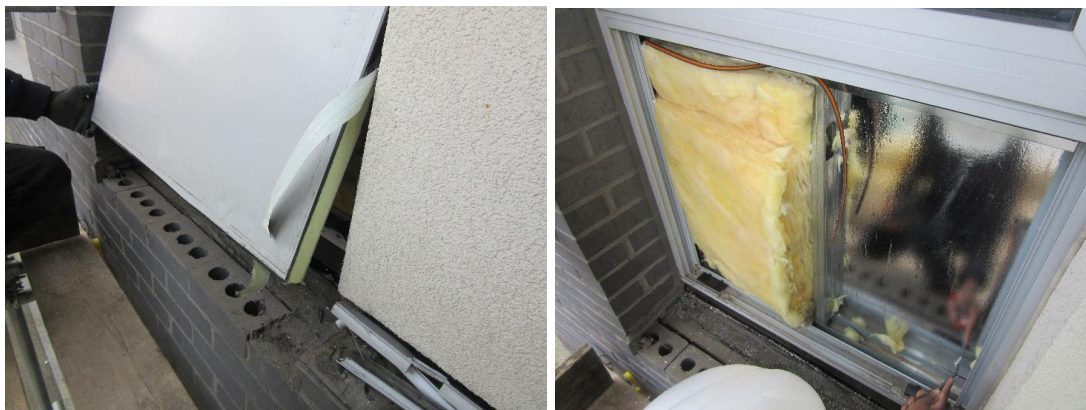
The spandrel panels (shown below) contain a man-made foam core, thought to be polyisocyanurate (PIR) foam.

The use of PIR foam in the spandrel panels is also non-compliant. These would meet the Class 0 requirement under the 2010 guidance but not the limited combustibility requirement for a building over 18m.

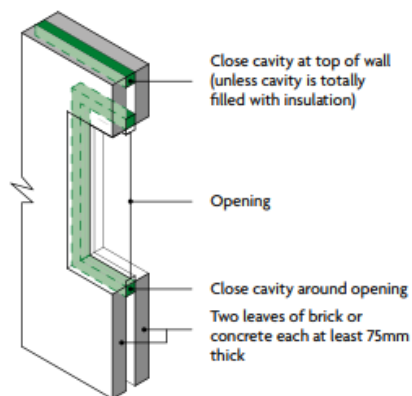
Provisions for Cavity Barriers

Cavity barriers were found at horizontal levels and at vertical compartment walls in the insulated render system cavity. Cavity barriers were not seen around openings in the render system as required (see diagram above), although this is unlikely to have been a specific requirement of the manufacturer’s guidance at the time of construction.

However, the barriers are not full thickness since the polystyrene is 120mm deep and the cavity barrier 100mm leaving a 20mm gap to the rear of the barrier, so an intumescent strip is provided behind the insulation.

Provide cavity barriers around all windows.

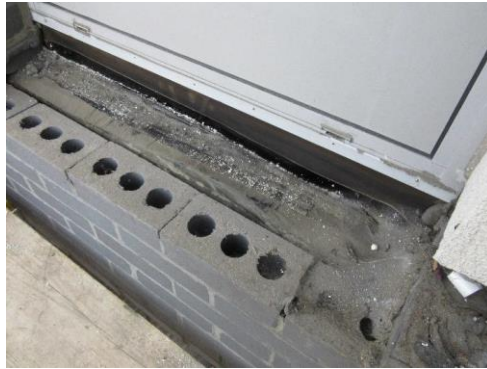
Cavity barriers were seen in the cavity formed by brickwork, after the windowsill was removed.
