Fire Risk Assessment of External Cladding Systems on High Rise Residential Building (Phase 3 Report)

Flats 1- 88 Dominion House
The Avenue
West Ealing
W13 8AE

Commissioned by: A2Dominion Group

Report date: 30/04/2020

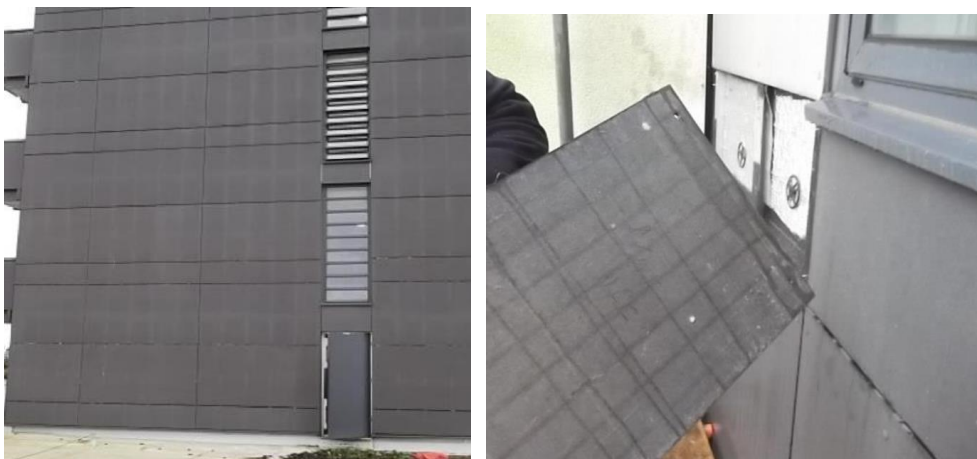
From the further intrusive survey carried out by FFT on 26 March 2020, the rainscreen cladding appears to be Etex Equitone Natura which has a BBA Certificate which confirms the product is a fibre reinforced cement panel. The product has an A2-s1,d0 reaction to fire classification. The BBA is not a system approval, however, and the Panels should meet Euroclass A2 standard as a minimum. This is confirmed in the certificate, although the build-up is not one that has BR135 approval as a tested system.

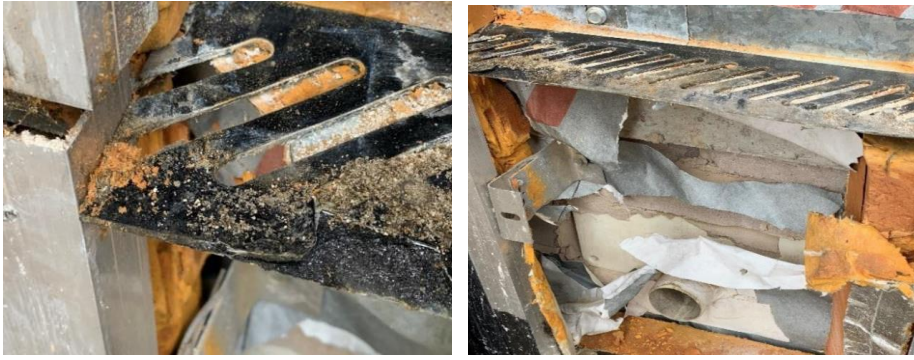
Metal ventilated horizontal barriers were noted at compartment floor level in both surveys. These barriers had an intumescent covering on them, designed to close the ventilation holes in case of fire.

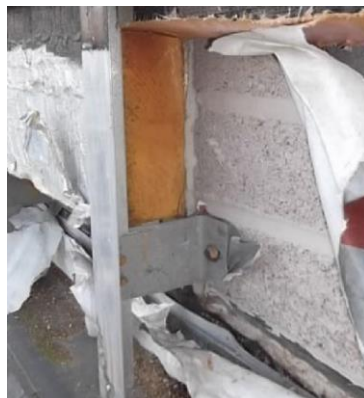
However, vertical barriers were not found in all locations expected. In the second intrusive survey, no barrier was found at the compartment wall between lift shaft and a flat.

However, the system is not in accordance with MHCLG guidance, in that the insulation is not A2 and the system has not passed the BS 8414 test. In neither of the two intrusive surveys were any barriers around openings such as windows noted, and some vertical cavity barriers were not found. In addition, penetrations formed by plastic vents through the phenolic board insulation were not fire stopped.

Either send full size sample of existing cladding build-up to be tested to BS 8414-2 and if successful retain (Euroclass B was the requirement at the time of construction) or replace with rainscreen cladding system that is compliant with Regulation 7 (2) i.e. minimum of Euroclass A2 and to include all appropriate cavity barriers.

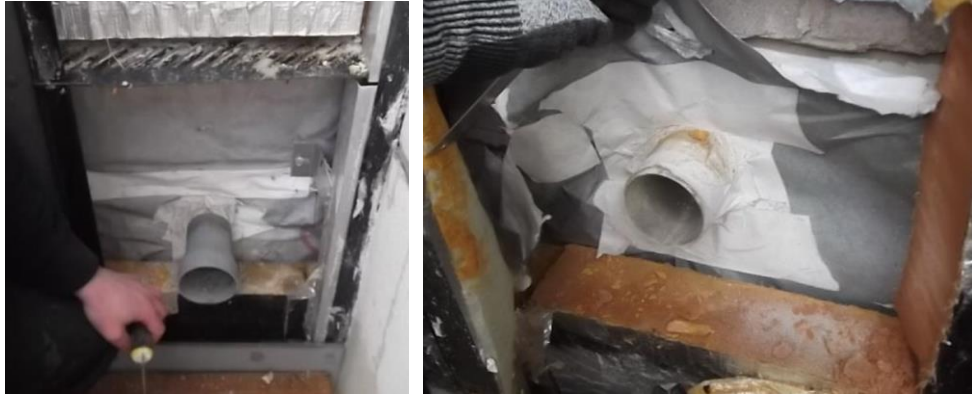
Plastic vents that penetrate the insulation have not been fire stopped. These require a fire rated wrap or sleeve to prevent the pipe melting and allowing a fire to pass into the insulation.

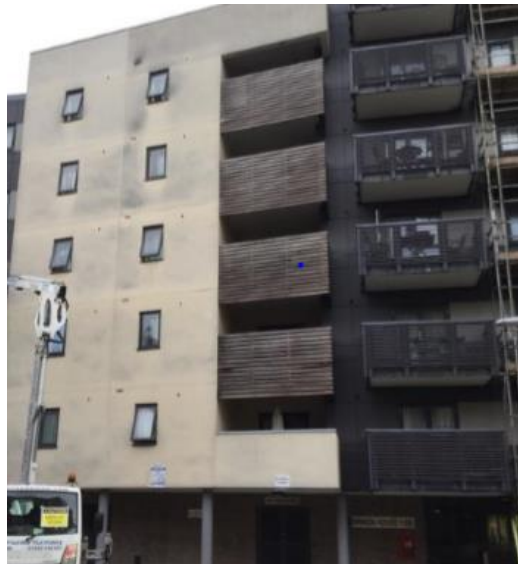
Balconies are provided to a number of flats. Although these have a solid, non-combustible base, they are clad in timber which is not in accordance with the guidance in ADB (B4) or MHCLG guidance which has clarified the issues of fire spread including balconies. The timber will require replacement with a Euroclass A2 rated material.

Replace timber on balconies with a Euroclass A2 or better material.
