## TECHNICAL GUIDANCE NOTE

### Fire Risk Assessment of External Cladding Systems on High Rise Residential Building (Phase 3 Report)

101 - 704 Shannon Apartments

Report issue date: 03/04/2020

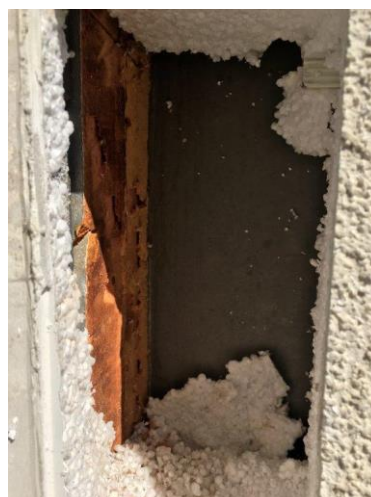
Within the masonry cavity phenolic foam board has been provided. This was noted to be exposed in one location opened up, at the junction between the masonry and rendered insulation.

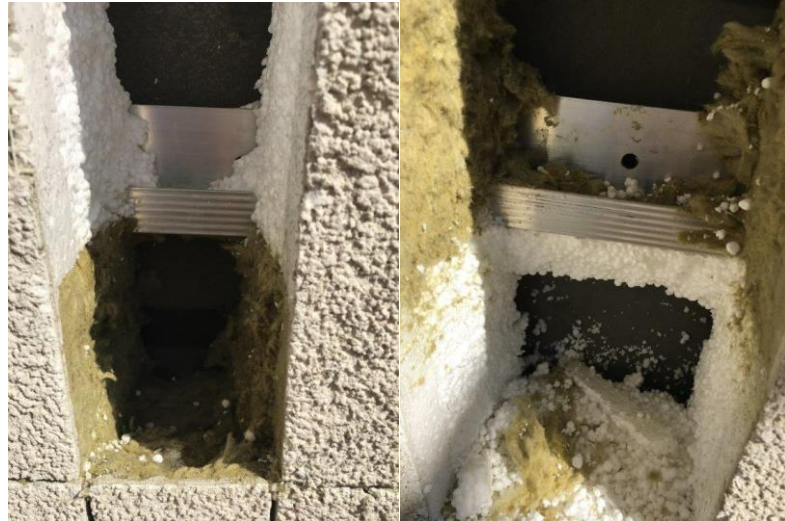
The mineral wool cavity barrier appears to be full-fill back to the cementitious board. However, it was noted that a cavity between the cementitious board and masonry, up to 18mm deep in places, has been created. There are no fire breaks in these cavities so it is assumed they are continuous from floor to roof level. A cavity barrier should be present at each compartment floor and wall level in this cavity.

Cavity barriers are required to be provided at each floor level and compartment wall. This could be achieved by opening up the render at each floor level and inserting a full width cavity barrier before making good the render.

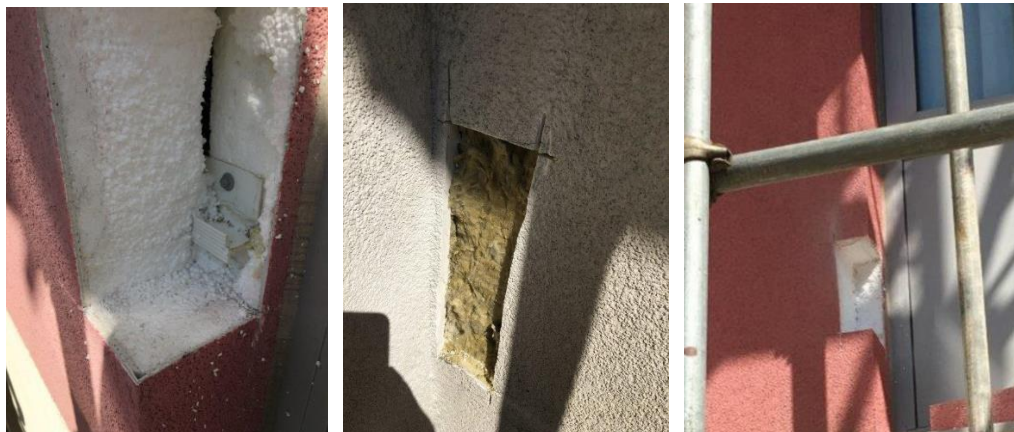
No cavity closers were found during opening up around windows and were present in some locations, but not all, where compartment walls were located.

Cavity barriers are also required around openings in the facades such as windows and doors.
