Fire Risk Assessment of External Cladding Systems on High Rise Residential Building (Phase 3 Report)

Flats 1- 88 Dominion House
The Avenue
West Ealing
W13 8AE

Commissioned by: A2Dominion Group

Report date: 30/04/2020

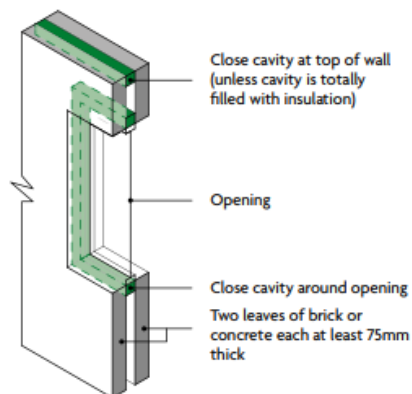
Provisions for Cavity Barriers

Metal ventilated horizontal barriers were noted at compartment floor level in both surveys. These barriers had an intumescent covering on them, designed to close the ventilation holes in case of fire.

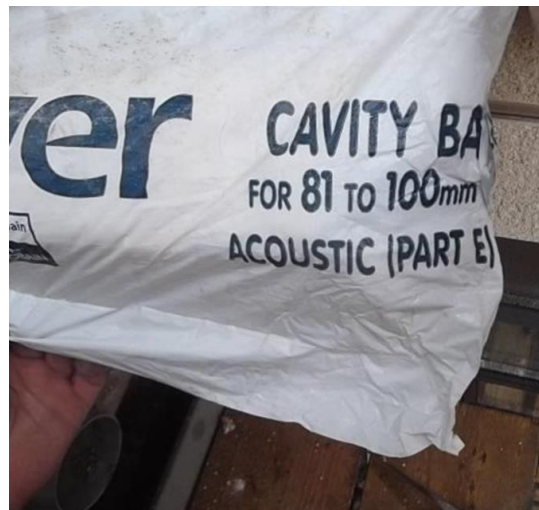
The Isover cavity barriers noted in the second intrusive survey appear to be the appropriate selection according to the manufacturer's details:

Product	Cavity size (mm)	Width (mm)	Length (mm)	Sleeve colour
Isover ULTIMATE™ Cavity Barrier - 30 minute	50 - 65	100	1200	Yellow
Isover ULTIMATE™ Cavity Barrier - 30 minute	66 - 80	100	1200	Blue
Isover ULTIMATE™ Cavity Barrier - 30 minute	81 - 100	100	1200	White
