FIRE RISK ASSESSMENT

Deans Court (17-31), East Block
3 St. Georges Road,
Bristol,
Avon, BS1 5UL

On Behalf Of: A2Dominion Housing Group Ltd
Conducted by: Mark Gilbert
Date: 30th April 2024

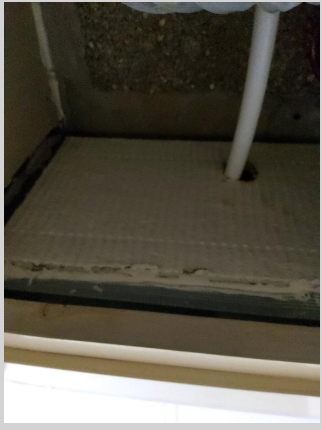
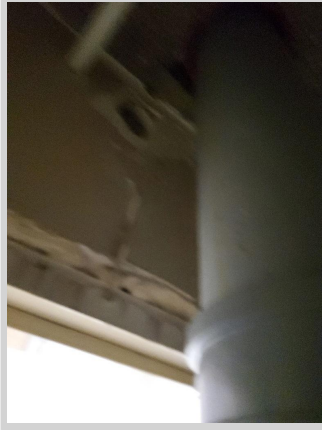
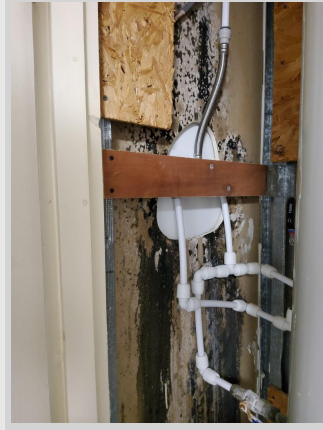
Question 7.7/1

1	Observation	Breaches in the fire compartmentation have not been fire stopped or have been fire stopped using materials and or systems that do not appear to comply with the requirements and / or recommendations of BS 476 and the ASFP colour guide books in the following locations:		
		<ol style="list-style-type: none"> 1. The pipework passing through the wall of duct 4 in flat 17 has not been suitably infilled. 2. There is a hole in the inside wall, above the door frame, to duct 1 in Flat 18 that has not been suitably infilled. 3. There is a hole in the inside wall, above the door frame, to duct 2 in Flat 18 that has not been suitably infilled. 4. There are breaches in the compartment wall between the bedrooms and duct 1 in flat 20. 5. There are breaches in the compartment wall between the bedrooms and duct 2 in flat 20. 6. There are breaches in the compartment wall between the bedrooms and duct 4 in flat 20. 7. There are breaches in the compartment wall between the bedrooms and duct 2 in flat 22. 8. There are breaches in the compartment wall between the bedrooms and duct 3 in flat 22. 9. There are breaches in the compartment wall between the bedrooms and duct 4 in flat 22. 10. There are breaches in the compartment wall between the bedrooms and duct 1 in flat 23. 11. There are breaches in the compartment wall between the bedrooms and duct 4 in flat 23. 12. The cabling passing through the inside wall, above the door frame, to the cleaner's cupboard in Flat 24 has not been suitably infilled. 13. There are breaches in the compartment wall between the bedrooms and duct 1 in flat 26. 14. There are breaches in the compartment wall between the bedrooms and duct 1 in flat 28. 15. There are breaches in the compartment wall between the bedrooms and duct 2 in flat 28. 16. There are breaches in the compartment wall between the bedrooms and duct 1 in flat 29. 17. There are breaches in the compartment wall between the bedrooms and duct 4 in flat 29. 18. There are breaches in the compartment wall between the bedrooms and duct 2 in flat 30. 19. There are breaches in the compartment wall between the bedrooms and duct 2 in flat 31. 20. There are breaches in the compartment wall between the bedrooms and duct 3 in flat 31.

Remedial works appear to be ongoing but yet to be fully resolved.

Action	Make good the breaches in the fire compartmentation using materials that comply with the requirements of BS 476 and systems that comply with the recommendations set out in the ASFP colour books or equivalent. Implement control measures to ensure that all future breaches are adequately stopped as and when they are made.		
	Priority	Medium	Target Date	
	Responsible Person		Cost	
Comments				
Stephen Broomfield 01/07/2022 19:35	This issue is partially resolved. The gaps around the ceiling hatch in Flat 30 have been suitably repaired.			
	The breaches around the pipework in the kitchen of Flat 25 remain unsealed.

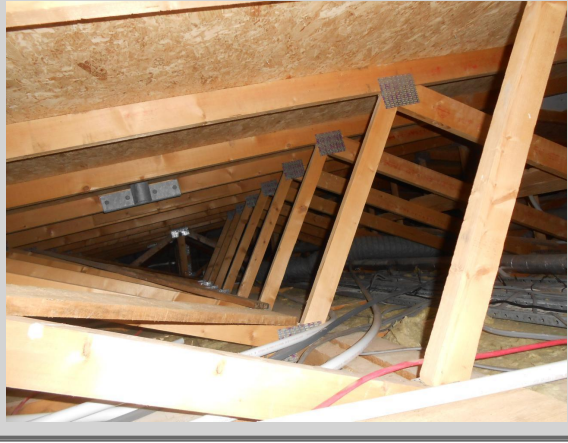
Question 7.11/2

2	Observation	Due to the lack of access to the loft spaces / roof voids, it was not possible to make a suitable assessment of the fire separation within these areas.		
	Action	Arrangements should be made to facilitate access to the loft spaces / roof voids to enable a suitable assessment of the fire separation to be made. See Action 8.1(4) regarding the need to survey the roof spaces for the coverage of fire detection.		
	Priority	Medium	Target Date	
	Responsible Person		Cost	
	Comments			
Stephen Broomfield 01/07/2022 19:35	This issue is unresolved.			
Stephen Broomfield 01/07/2022 19:37	Although the presence and status of total vertical separation in the roof voids could not be ascertained during the review visit on 13/06/202, the assessor was informed that the fire detection and alarm system was extended into the roof voids of all four blocks on the site in January 2022.			
Mark Gilbert 09/05/2024 10:55	Unable to confirm that this has been resolved.
