FIRE RISK ASSESSMENT

Deans Court (50-68), West Block
3 St. Georges Road,
Bristol,
Avon, BS1 5UL

On Behalf Of: A2Dominion Housing Group Ltd
Conducted by: Mark Gilbert
Date: 30th April 2024

Job Number: 196756

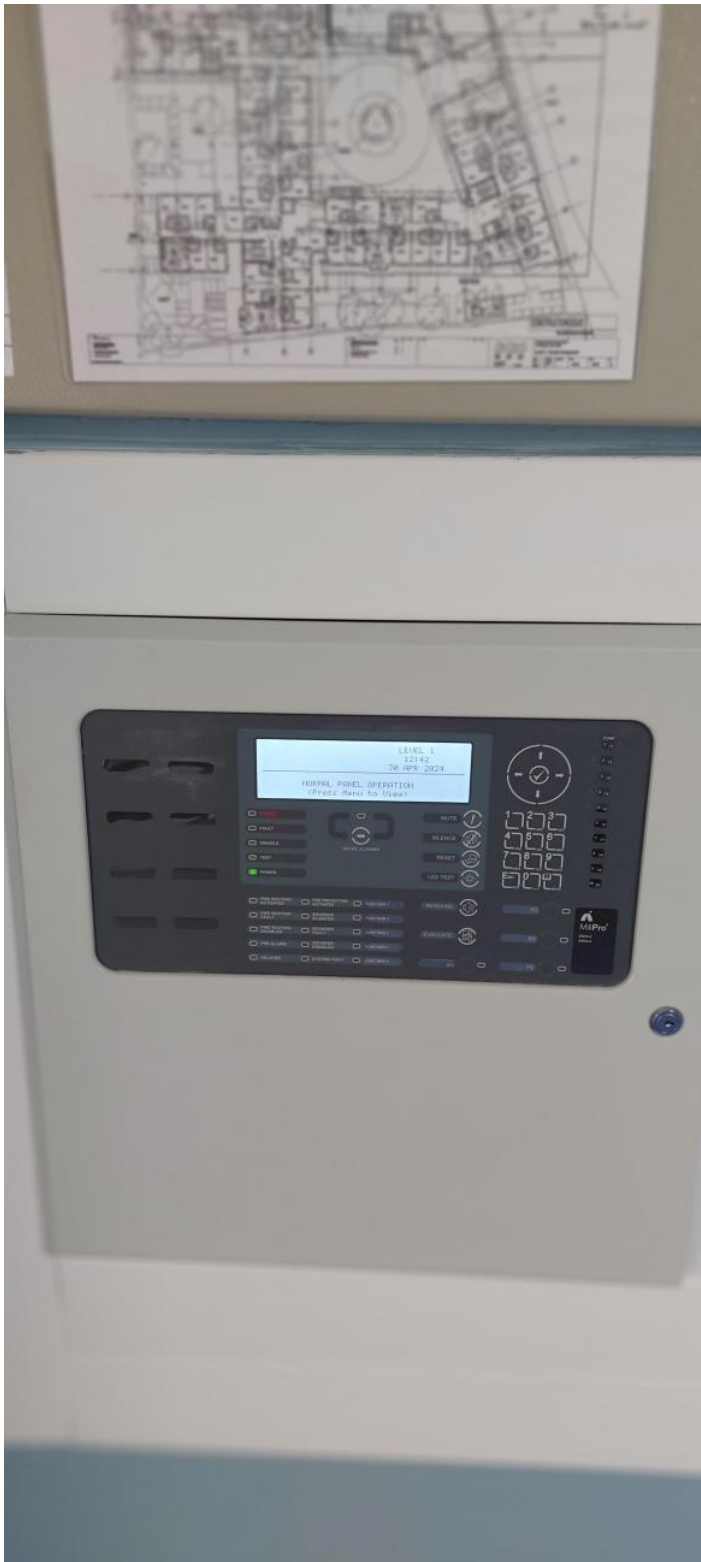
Main panel with plan drawing above.
