# FIRE RISK ASSESSMENT

UPRN 152832 Flats 18-50 Gosse Court, London, N1 5BF

On Behalf Of: A2Dominion Housing Group Ltd

Conducted by: Rick Davidson
Date: 29th June 2023

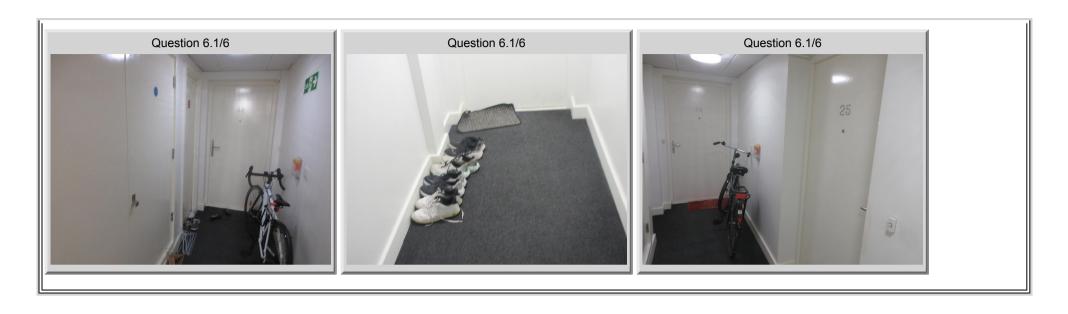
Davidson
There was no confirmation seen that residents had been advised on what they can store. However; the same bike was in the corridor by Flat 46 which also had shoes and coat hangers around the floor providing additional trip hazards. There was also a bike outside Flat 24 entrance door and a row of shoes outside Flat 39 entrance door.

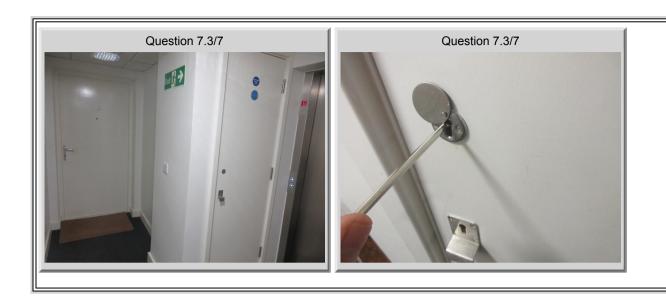
Observation	The assessor was unable to unlock the riser cupboards adjacent to the lift on the 5th, 3rd and 2nd floors. These appear to have damaged or broken locks.				
	Action	is recommended the locks in the doors noted are repaired or replaced.				
7	Priority	Low	Target Date	19th July 2024		
ľ	Responsible		Cost			
	Person		Cost			
	Comments

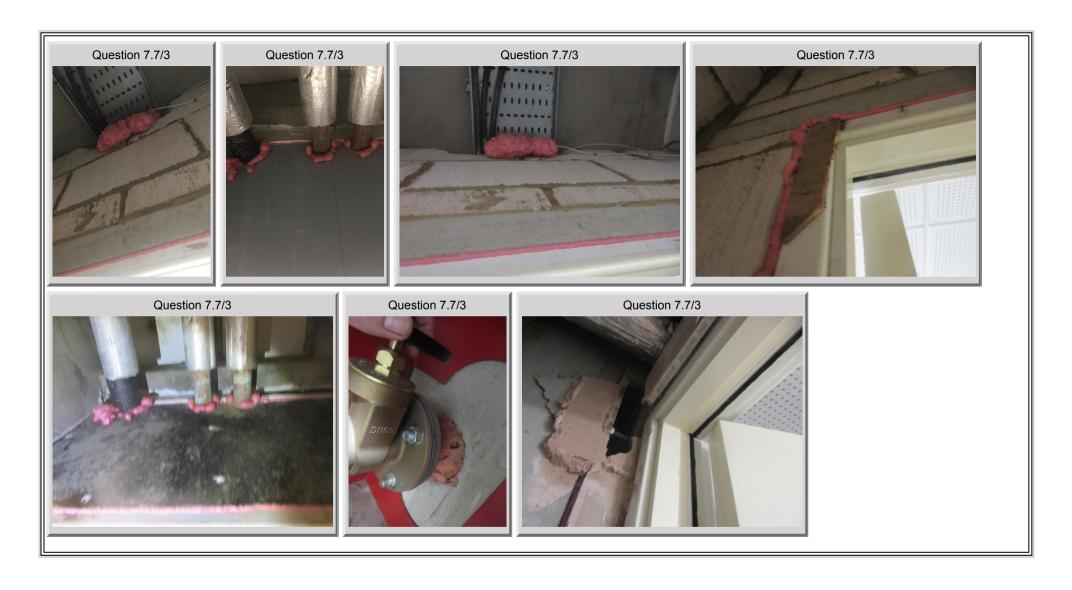
7.7	So far as can be unstopped pene		f this assessment, do al	elements of compartmentation in the premises appear to be intact, in sound condition, and free from			
3	Observation	through is poor.	The fire stopping to compartmentation seen throughout the common parts, including plant rooms and service risers where services have been passed through is poor.  See 1-17 Gosse Court for additional pictures.				
	Action	Confirm by means of an intrusive survey, that the elements of construction are constructed in such a way and from materials that will provid degree of fire resistance for each particular element of fire compartmentation					
	Priority	Medium	Target Date				
	Responsible Person		Cost				
	Comments						
Mark Gilbert 08/08/ 2022 10:23	Outstanding action from previous report.						
Rick Davidsor 16/07/ 2023 14:38		ain outstanding action from pre	vious report
